# TECHNICAL SERVICE INFORMATION

MODEL	F(L)115B
SUBJECT	FIELD CORRECTION FOR THROTTLE BODY BRACKET

## FIELD CORRECTION

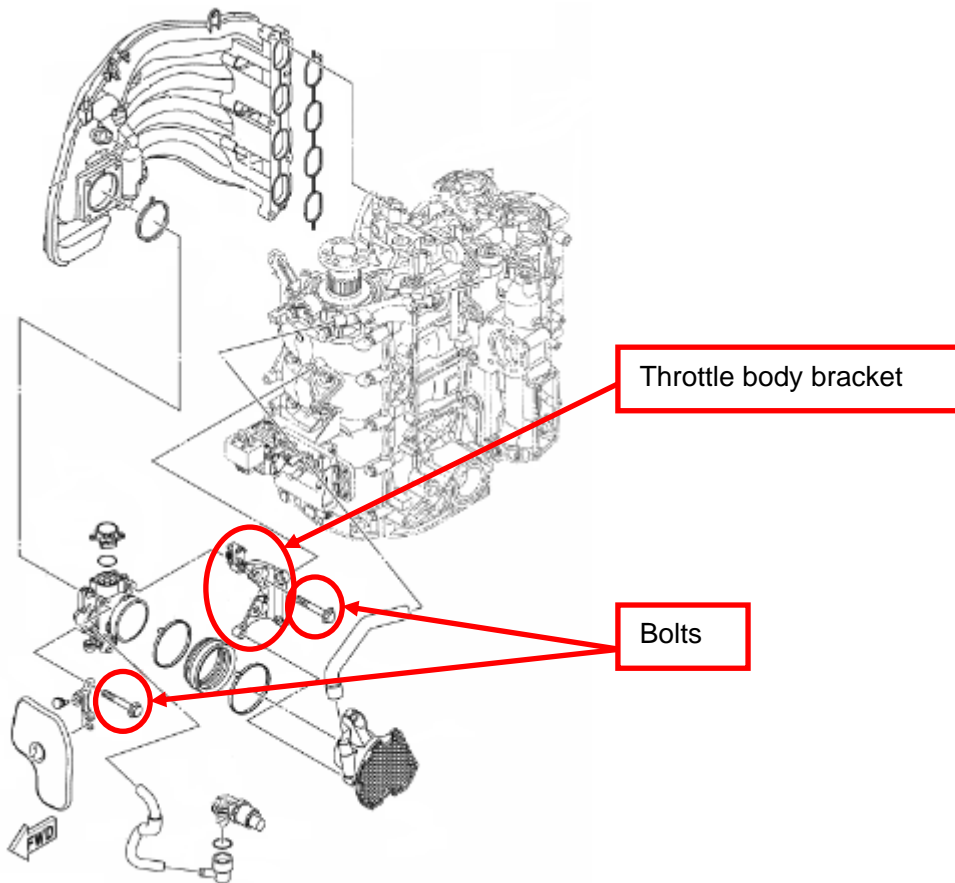
The throttle body bracket fitted on the above-mentioned model has been found to be defective. While the engine is running, the throttle body bracket may break due to engine vibration and the main harness may lose its electrical continuity to ground, causing the engine to stop or become unable to restart. To prevent this problem from happening, field corrections will be performed to replace the throttle body bracket on the above-mentioned model with a new, countermeasure part.

Replace the throttle body bracket and throttle body bracket bolts with new, countermeasure parts.

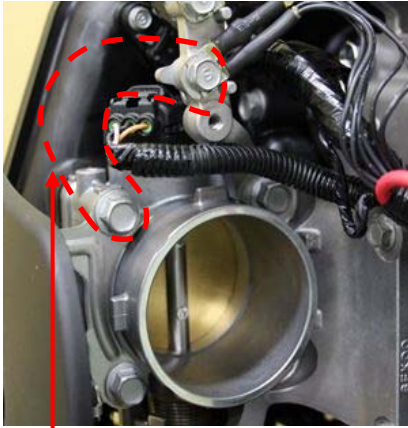
Without extension wire lead

There is no extension wire lead

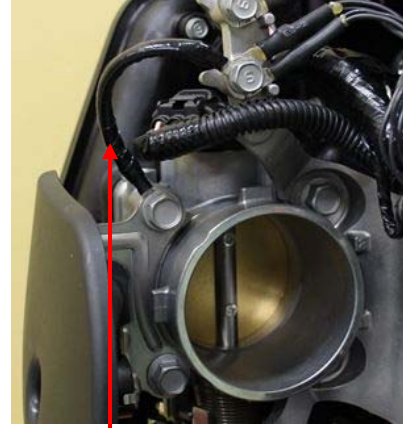
With extension wire lead

Extension wire lead attached

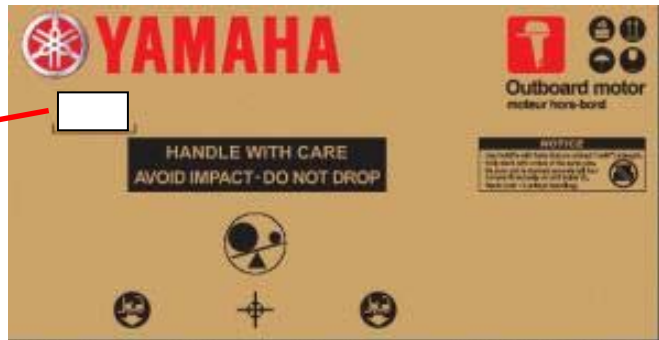
Distinguishing mark (red paint mark)

\* Replacement with new parts has already been performed on some units included in the above table. Make sure to check the distinguishing marks shown below before starting the work. (The red paint mark on the tag affixed to the package carton and the yellow paint marks on the ground bolts indicate that the replacement has been completed.)

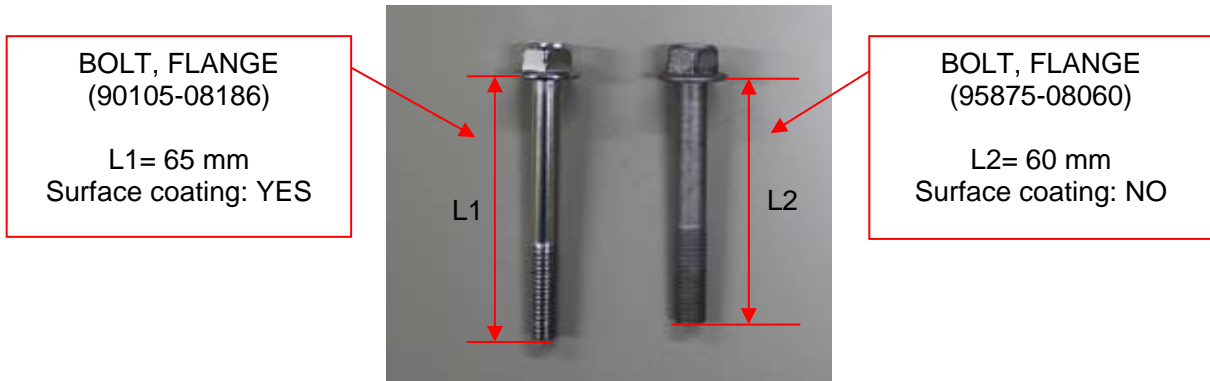
\*2. Dimensions of both BOLT, FLANGE (90105-08186) and BOLT, FLANGE (95875-08060) are shown below. Make sure to distinguish properly between the two types of bolts.

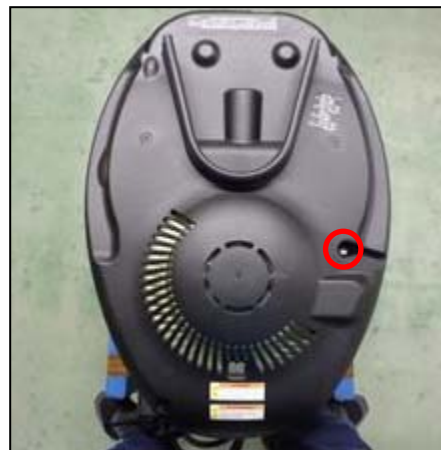
1. Remove the bolt and the flywheel magneto cover.  
M6 (30 mm) x 1

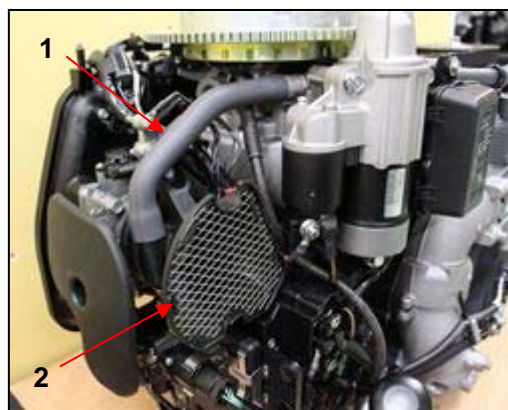
2. Remove the blowby hose “1” and the 2 bolts, and then remove the intake silencer “2”.  
M6 (25 mm) x 2

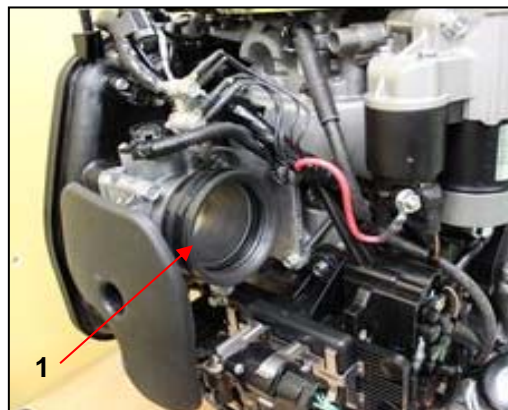
3. Remove the joint “1”.  
TIP: Do not cut and remove the plastic tie attached on the joint. Pull and remove the joint with the plastic tie attached.

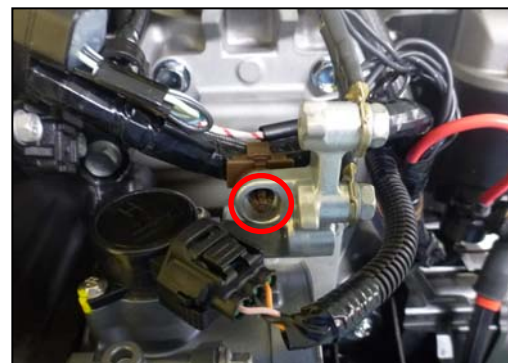
4. Remove the clamp fastening the main wire lead (below the ground lead) from the throttle body bracket.  
TIP: Squeeze the claws of the clamp using long nose pliers to remove it from the throttle body bracket.

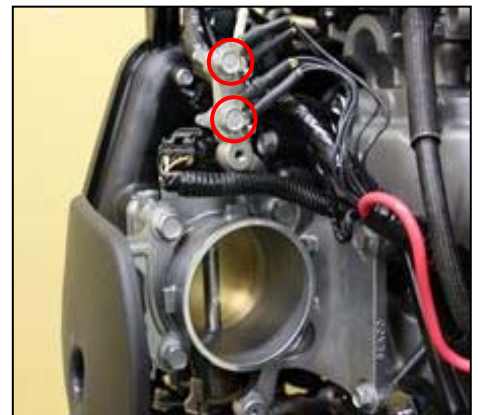
- Remove the 2 ground bolts from the throttle body bracket.  
Ground bolt: M6 (16 mm) x 2

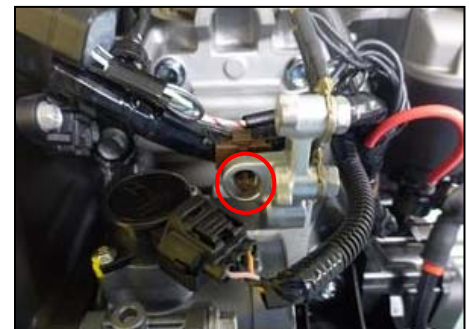
11. Reinstall the removed clamp onto the main wire lead (below the ground lead) in its original position.  
 TIP: Make sure to confirm that the claws of the clamp are securely fit into the opening in the throttle body bracket.

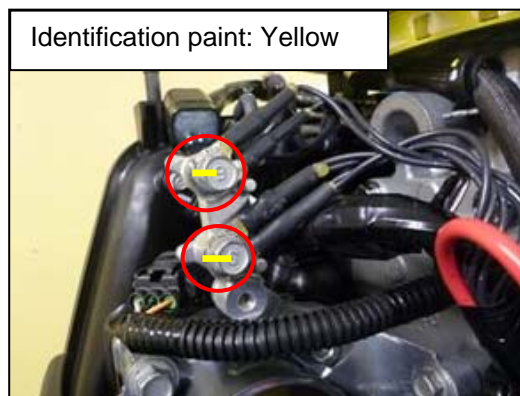
14. Put identification paint marks on the ground bolts, ground lead and throttle body bracket as shown in the picture.

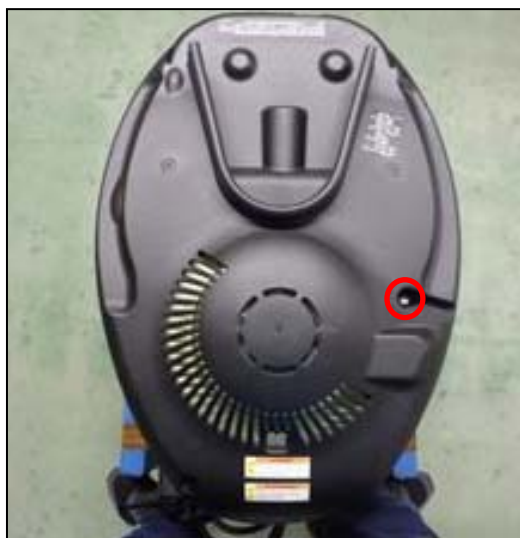
15. Install the flywheel magneto cover and tighten the bolt to the specified torque. The replacement is complete.

M6 (30 mm) x 1  
Torque: 8 Nm (0.8 kgf·m)

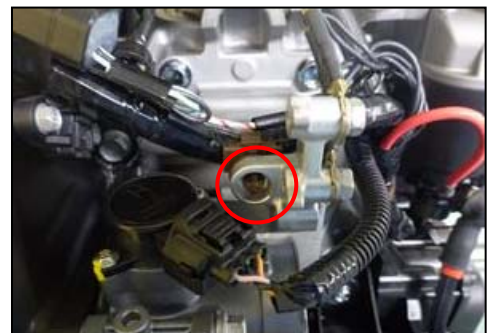
23. Reinstall the removed clamp onto the main wire lead (below the ground lead) in its original position.

TIP: Make sure to confirm that the claws of the clamp are securely fit into the opening in the throttle body bracket.

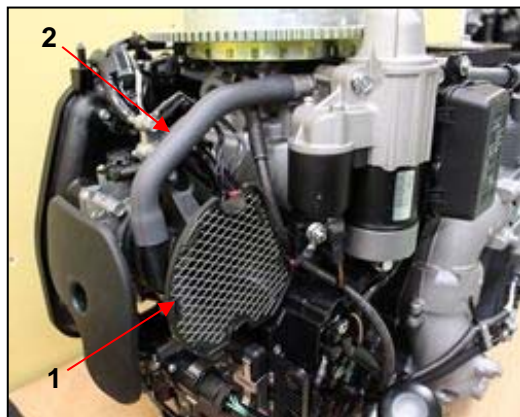
25. Install the intake silencer "1" and blowby hose "2" and tighten the 2 bolts to the specified torque.

M6 (25 mm) x 2  
Torque: 8 Nm (0.8 kgf·m)

TIP: Be careful that the harnesses or ties are not caught between parts. Make sure that the blowby hose is securely inserted.

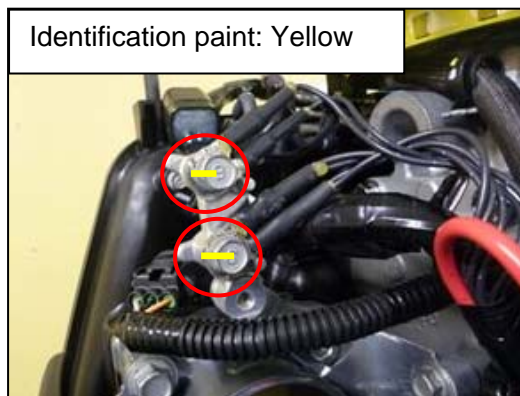
26. Put identification paint marks on the ground bolts, ground lead and throttle body bracket as shown in the picture.

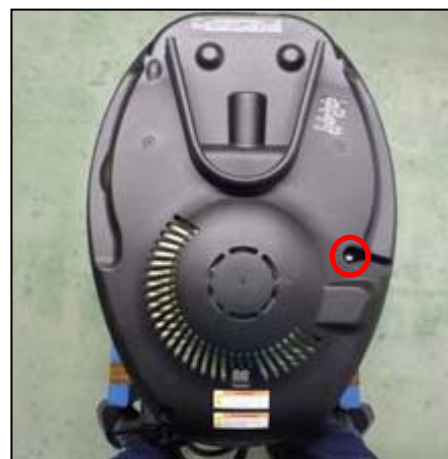
27. Install the flywheel magneto cover and tighten the bolt to the specified torque. The replacement is complete.

M6 (30 mm) x 1  
Torque: 8 Nm (0.8 kgf·m)
